Phase 1 Environmental Site Assessment Precinct 2a (Bridge Inn Road and Cookes Road), Mernda, Victoria

Prepared for:
Bridge-Cookes Landowners Group Inc.
220 Cookes Road,
Doreen Vic 3754

15 May 2020

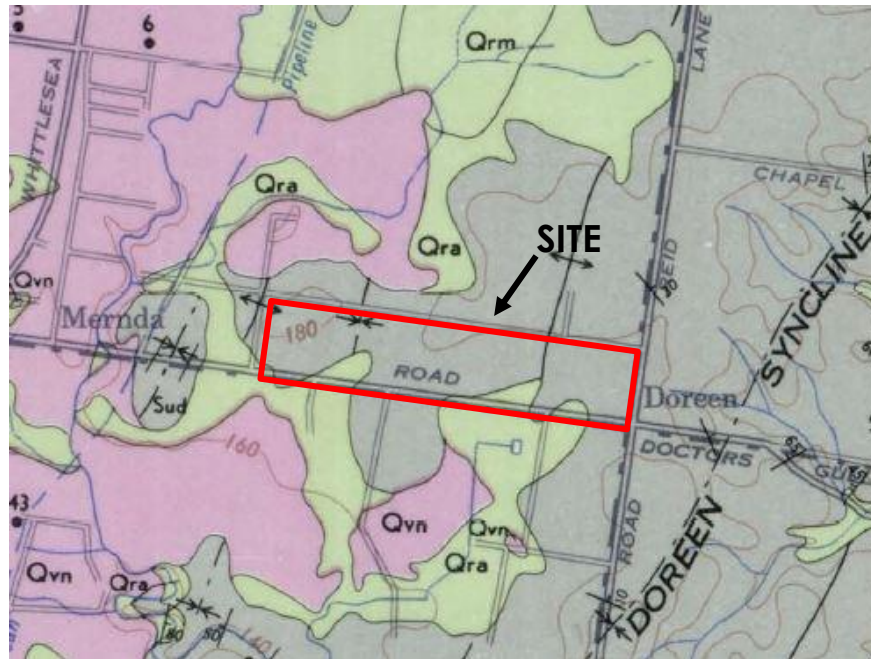
Figure 2.1 Local geology from the 1:63,360 Yan Yean Sheet 7822 (Source: Geological Survey of Victoria, 1974).

A review of the Geological Survey of Victoria 1:63,360 Yan Yean Sheet indicates that the site is predominantly underlain by Silurian aged siltstone and sandstone, part of the Melbourne Formation Group (Sud) which comprises of sandstone, laminated and current bedded, with interbedded siltstone and shale and hornfels in metamorphic aureoles near Quarry Hill. The southern portion of the site is underlain by quaternary aged alluvial sediments (Qra), consisting of river alluvium; sand, silt, clay and minor gravel. Refer to in **Figure 2.1** below for an excerpt of the geology map.

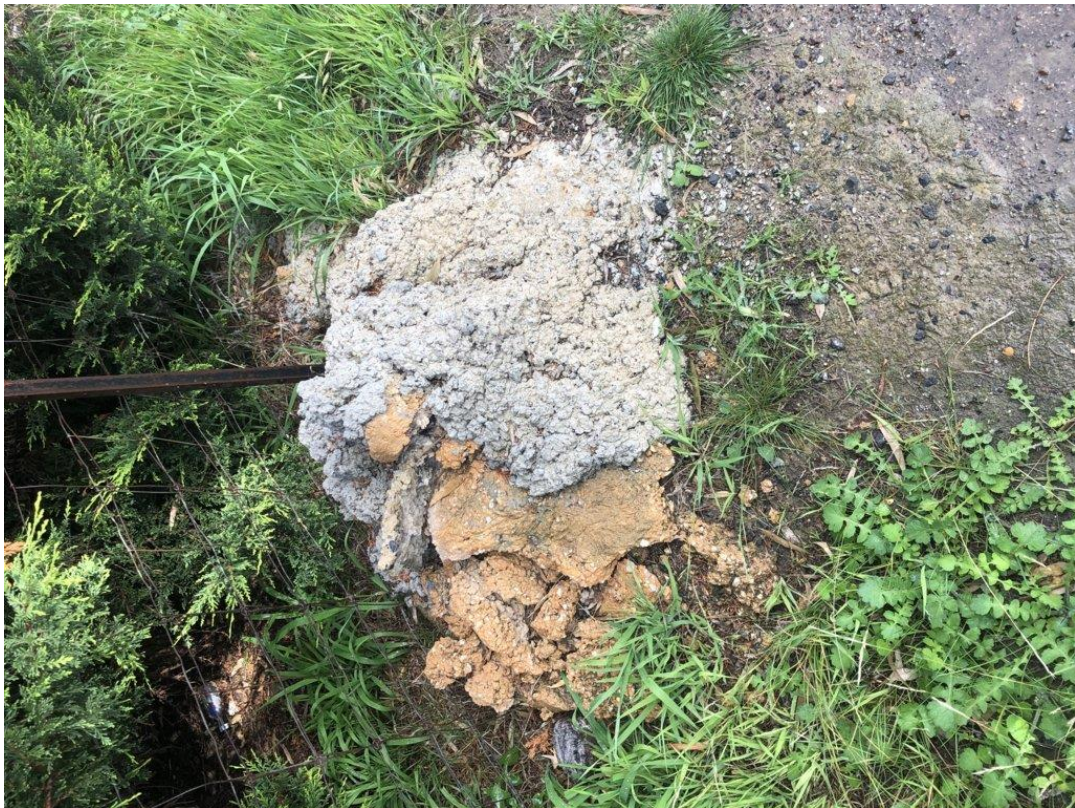
Photograph 2

Small pile of clay soils found on the eastern end of Cookes Road

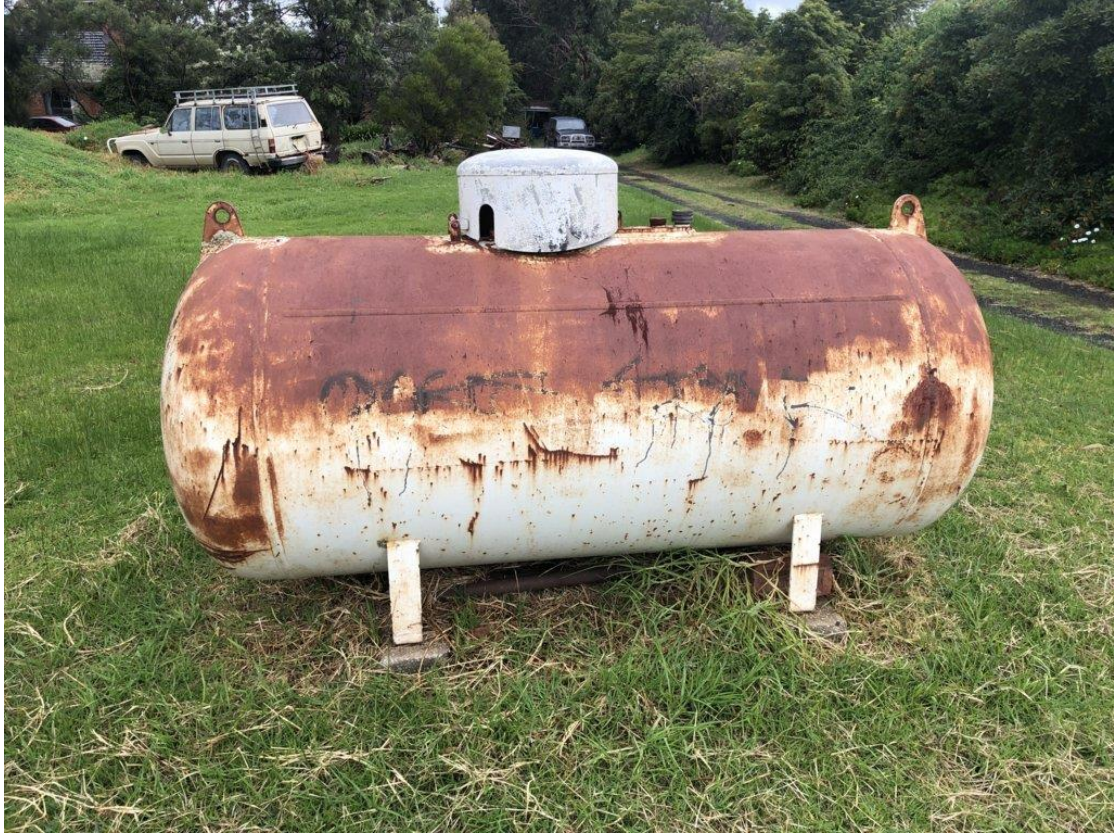
Photograph 7

| Landserv Property ID | Lot Number | Observations |
|---|---|---|
| 9 | 214 Cookes Rd | An old truck and a car and general rubbish are located in the front yard. A tin shed is located towards the rear of the front yard. Two stockpiles covered in vegetation are located in the front yard of the site. A rusted above ground storage tank was located in the front yard of the site – its previous/current contents are unknown. |

Rusted old storage tank, previous contents unknown, on lot 214 Cookes Road

| Landserv Property ID | Area I.D | Property Address | Areas of Potential Environmental Interest | Possible action If property is to be redeveloped. |
|---|---|---|---|--|
| 9 | Area B | 214 Cookes Rd | Storage tank of unknown contents and barrels of unknown contents noted on multiple sites; | A Detailed Site Investigation (DSI) including but not limited to a targeted soil sampling in the vicinity of the AST and storage barrels below base of evident contamination (if present). If soil contamination data suggests groundwater impacts are possible, then investigate this. |

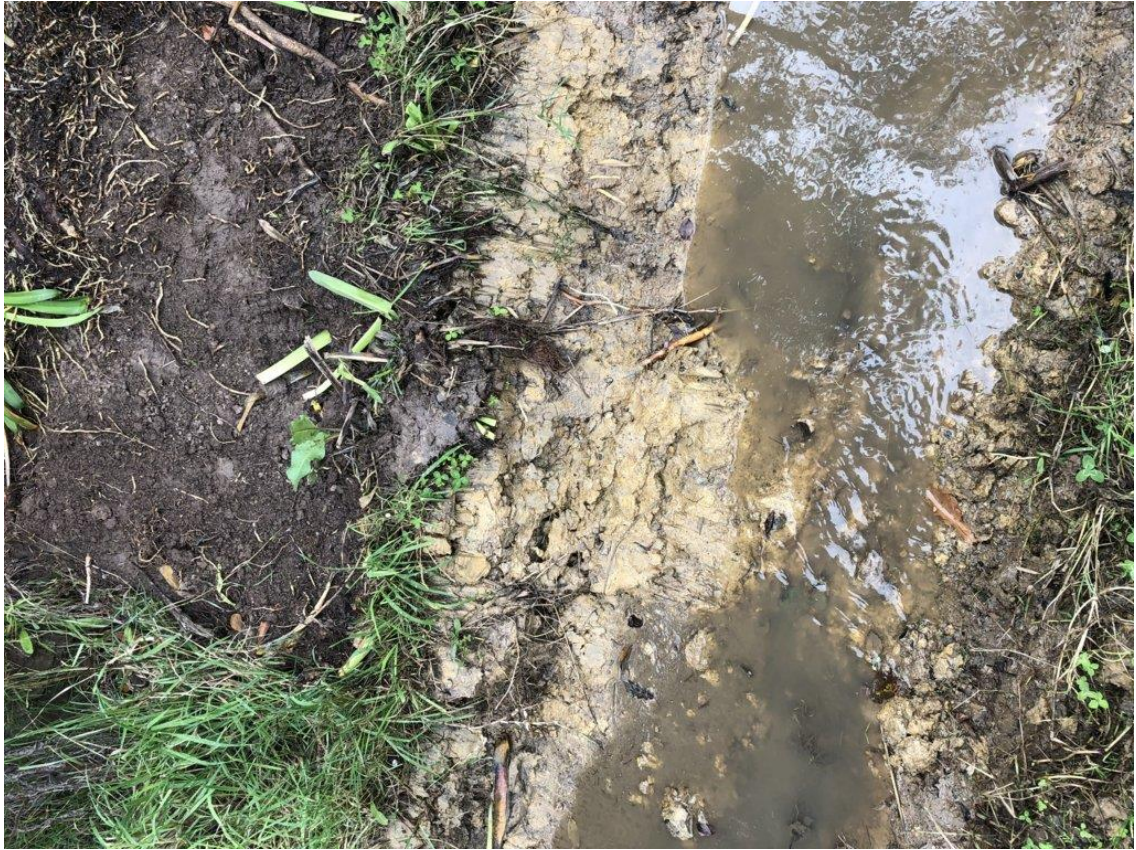
Photograph 9

Clayey soils found in the walls of the channel along Bridge-Inn Road

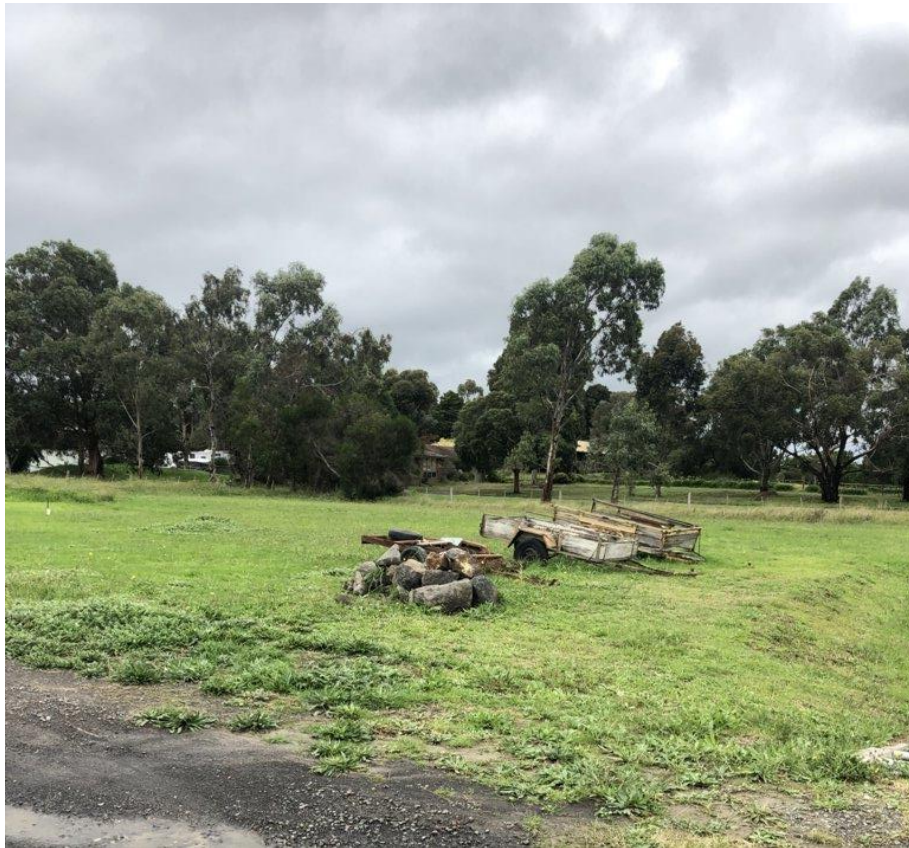
Photograph 10

| Landserv Property ID | Lot Number | Observations |
|---|---|---|
| 38 | 891 Bridge Inn Rd | The site was predominantly vacant with the exception of a small stockpile of soil located in the front yard of the site. Waste material was noted on site. |

Old trailers and hard rubbish observed on lot 891 Bridge-Inn Road
